**Flood Control Project Maintenance
Levee Inspections**
LMA District Cover Sheet
Spring 2009 Levee Inspection Results

Cache Creek

**Flood Control Project Maintenance
Levee Inspections
Unit Cover Sheet
Spring 2009 Levee Inspection Results
Cache Creek**

Levee Inspection Report By Mile - Spring 2009

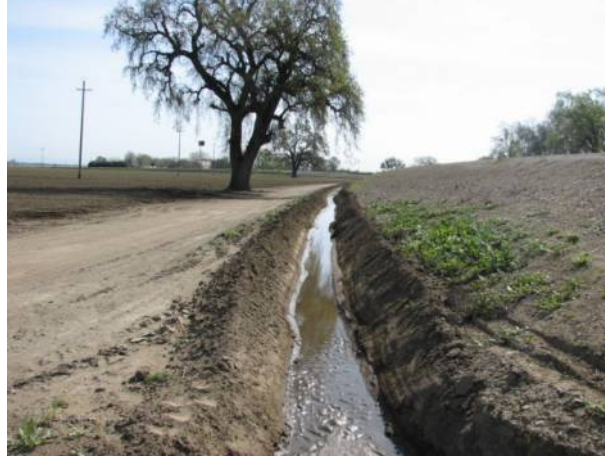
Levee Mile Report Line	39
Start Levee Mile	6.94
End Levee Mile	7.23
Location	Land Side
Category	Earthen Levee
Item	Encroachments

new ditch this spring

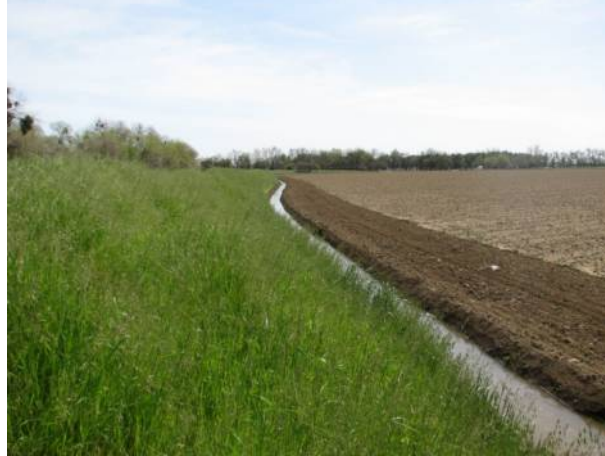
Levee Mile Report Line	8
Start Levee Mile	2.60
End Levee Mile	3.00
Location	Land Side
Category	Earthen Levee
Item	Encroachments

ditch along toe new
